Well Water Quality Update and Next Steps

Public Works Commission Meeting
April 17, 2017

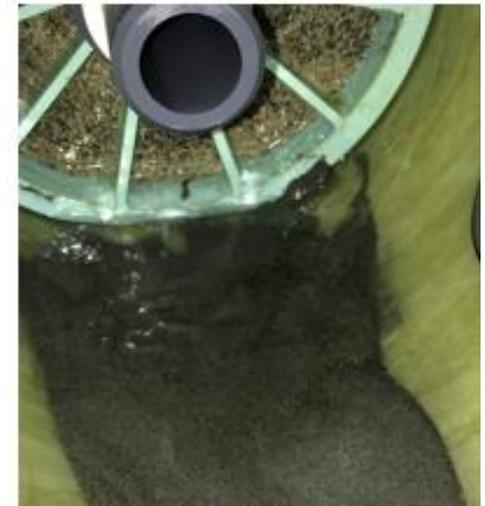
- Accumulation of black particulate matter in the protective cartridge filters prior to the RO membrane train (refer to Treatment Plant Flow Diagram).
- Much more prevalent sanding with very fine sand particles.
- High variable range and steady state levels of dissolved manganese in groundwater.

Fine Sand and Black Particles at RO Inlet

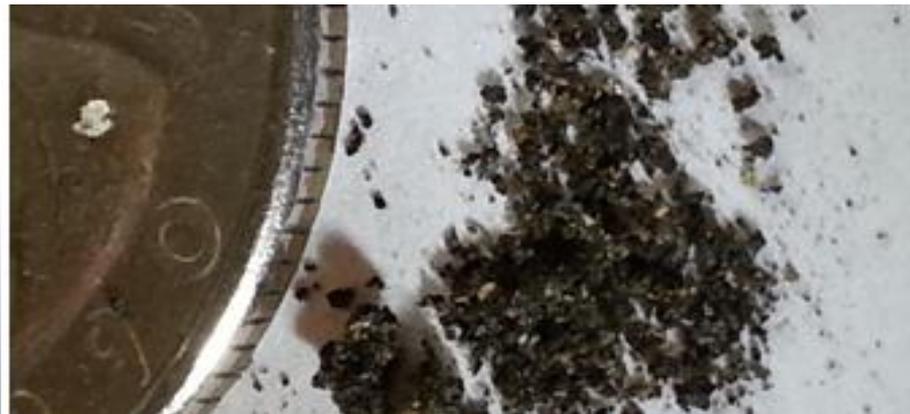
- Fine black particulates were observed with the sand analysis of the material captured at each well, in the plant feed and passing through existing & new cartridge filter vessels was identified and confirmed the presence of iron sulfide in all four (4) wells.
- The iron sulfide is formed from iron and sulfur that are naturally occurring in the reducing environment of the Hollywood Basin.
- Limits options for isolating wells.

Black Particles inside a Plant Cartridge Filter (a quarter is shown in the image for scale)

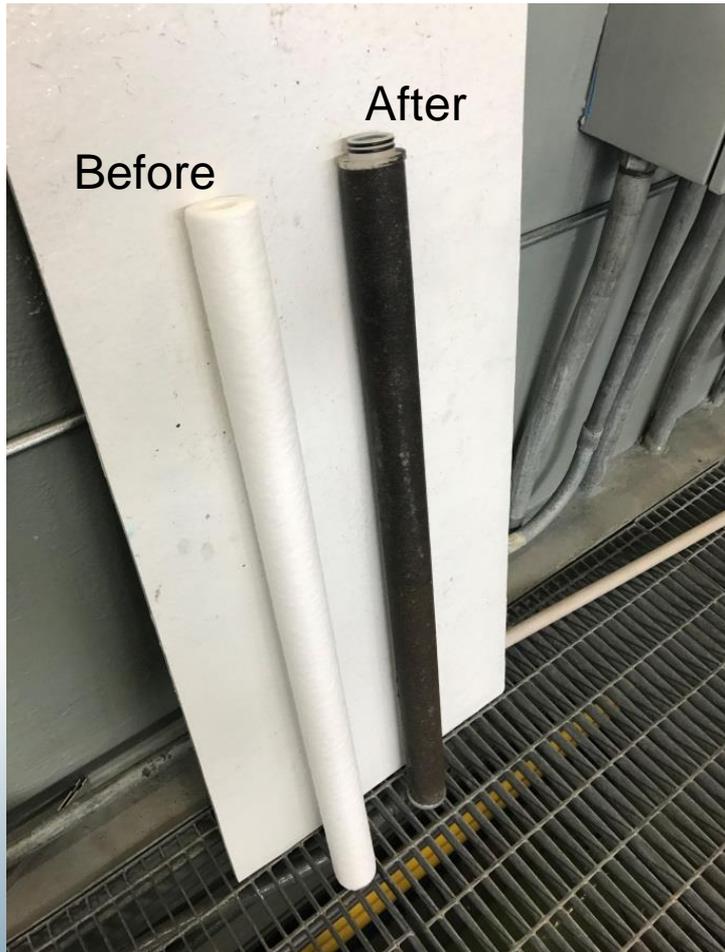
The following photographs show the material that was collected during the investigation:

- Sand/Particulate matter are passing through both existing and new cartridge filters.
- Sand/Particulate matter would break through to the distribution system.
- Sand and Particulate matter are both very fine (90% less than 10 microns); Current instruments are unable to detect break through.

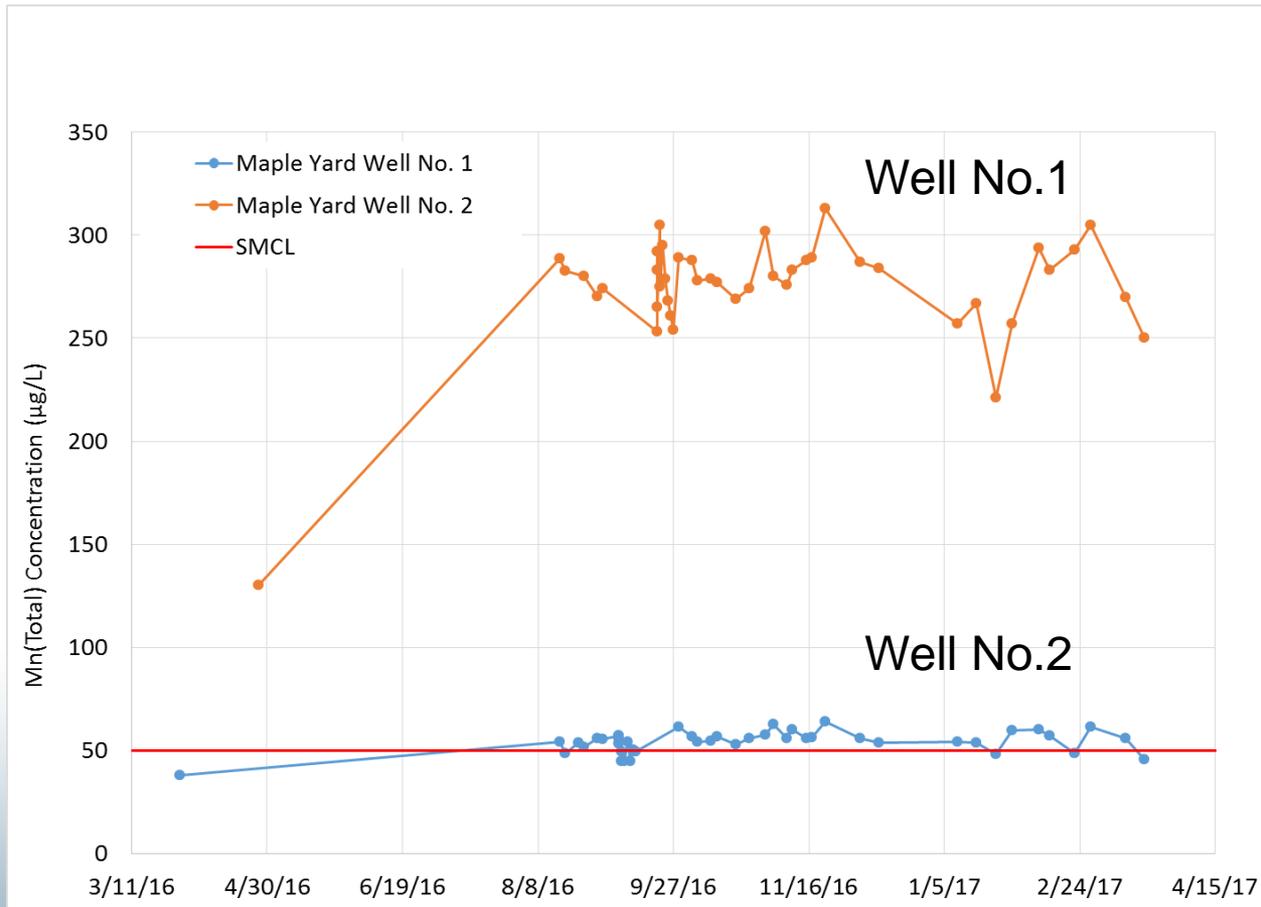
Maple Yard Wells

The New Normal – Dissolved Manganese
