Well Water Quality Update and Next Steps

Public Works Commission Meeting
April 17, 2017

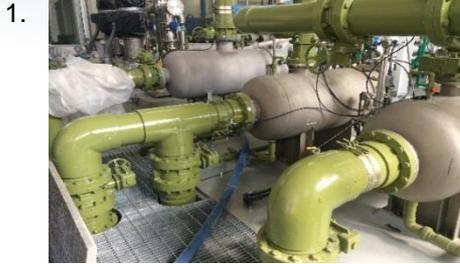
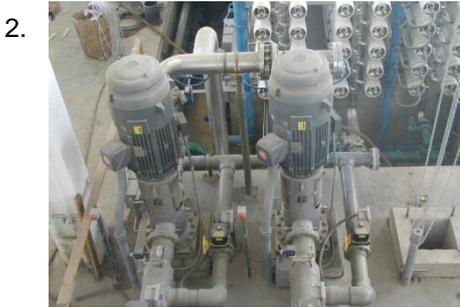
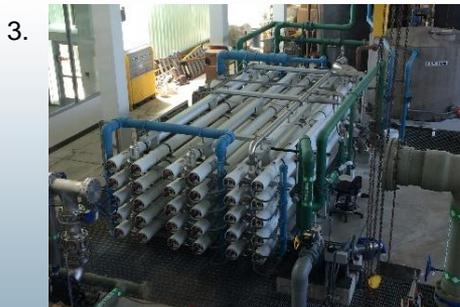
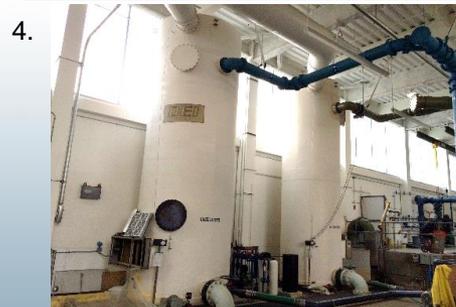
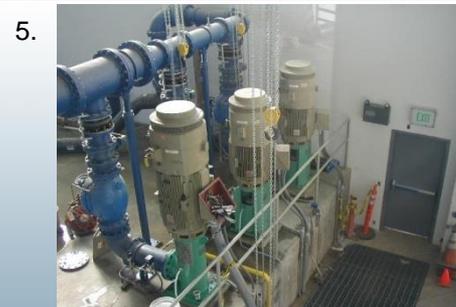
Treatment Plant Flow Diagram

Treated Water	Blue
Raw Water	Green

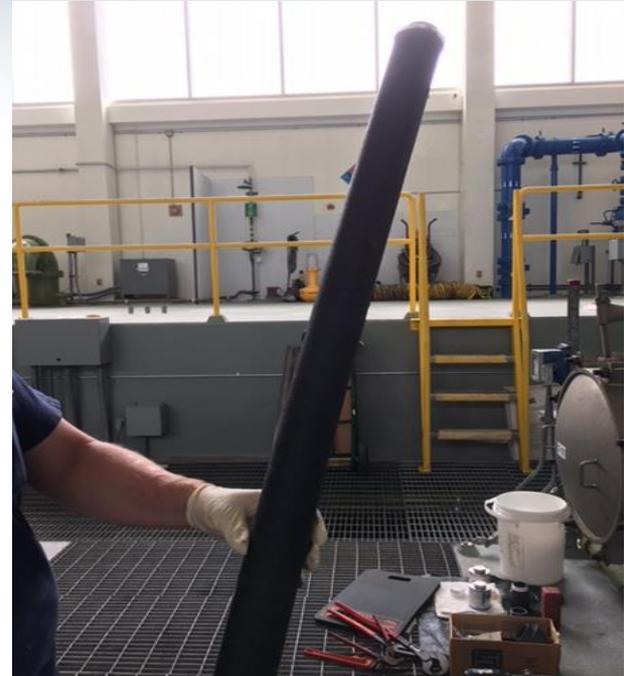
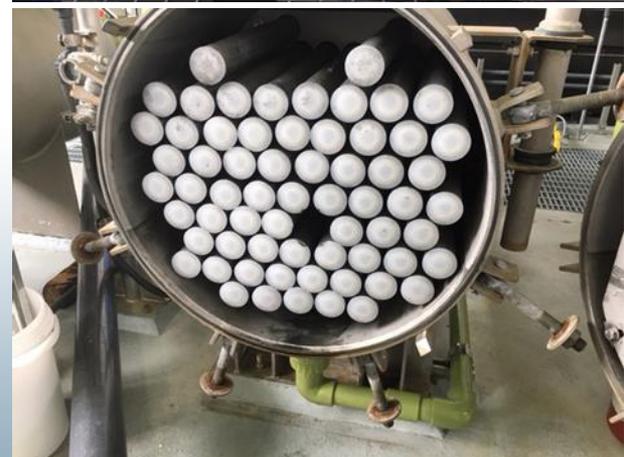
- Since the plant incorporates a blend of chlorinated raw water with the treated RO permeate water in a clear well (storage tank), iron sulfide would eventually show up in the City's distribution system.
- Iron sulfide can lead to customer complaints regarding discoloration, "metallic" taste, and odor issues and equate to negative public perception issues.

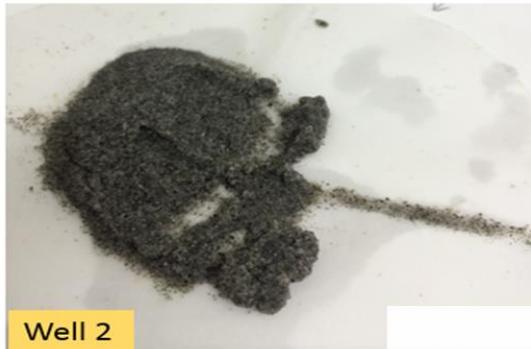
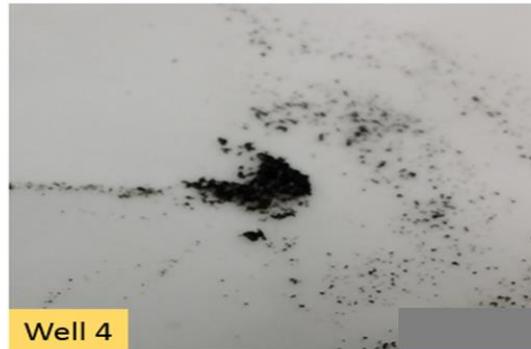
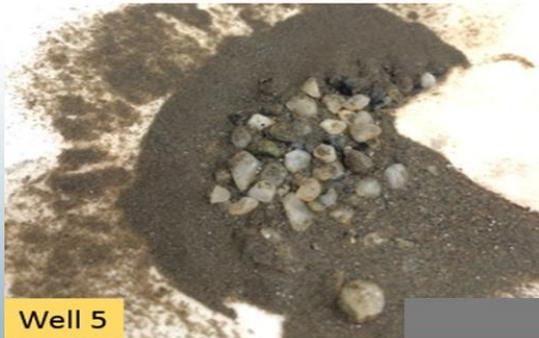
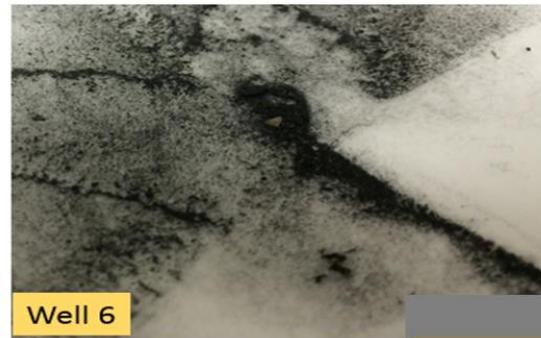
- Sanding volume is greater than the plant staff had observed historically and was no longer filtered by the WTP cartridge filters. (both existing & new).
- A well investigation for particulate intrusion confirmed the sand and fine black particulate matter present in all four wells.
